Project Name: Horniman Primary School SE23 3BP
Project Description: SITE DRAINAGE SURVEY
Project Number: 00251454
Project Status: Complete
Project Date: 17/02/2022

The closed-circuit television survey was carried out to check and map the location of the drains/manholes for the school as they will be having a new surface put down in the pen.

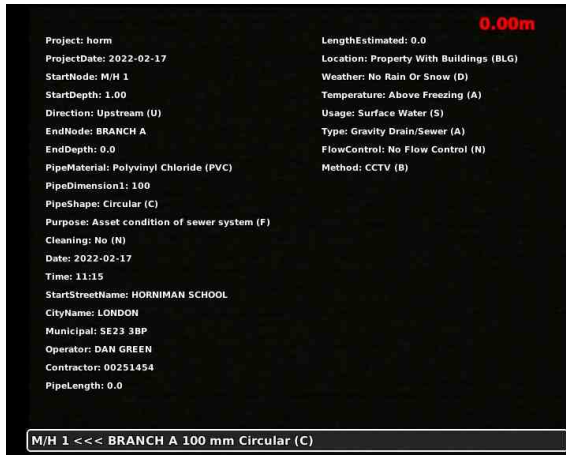
20220217-111633-snap0000.jpg, 00:00:02, 0.00 m
Start node, manhole, reference: 1

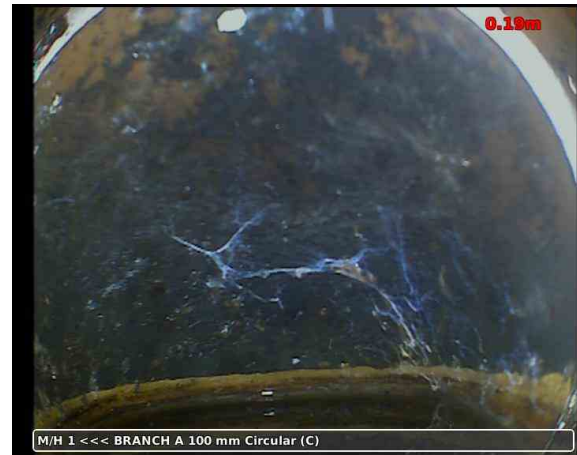
20220217-111633-snap0001.jpg, 00:00:36, 0.19 m
Finish node, catchpit, reference: BRANCH A - CATCH PIT

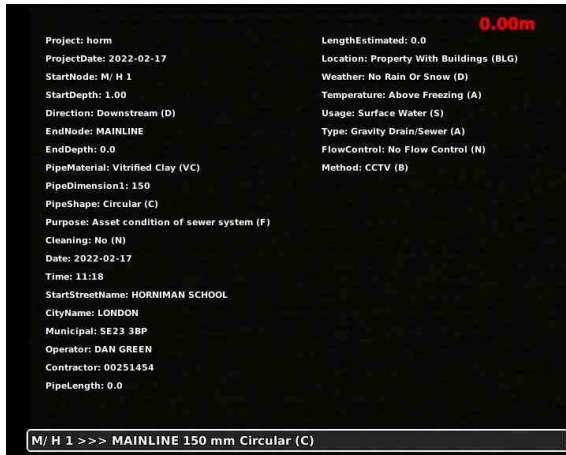
20220217-111814-snap0000.jpg, 00:00:02, 0.00 m
Start node, manhole, reference: 1

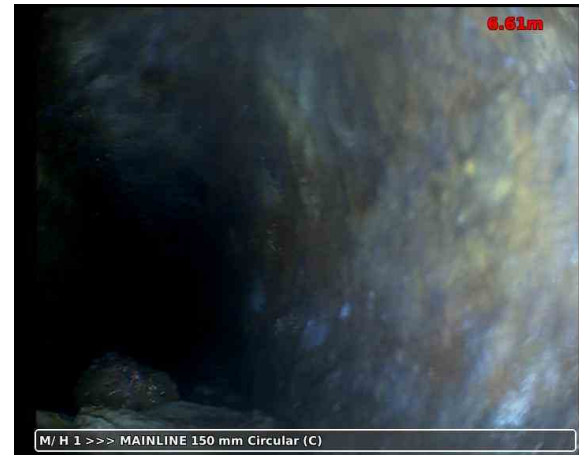
20220217-111814-snap0001.jpg, 00:01:51, 6.61 m
Settled deposits, other, 15% cross-sectional area loss, SCALE

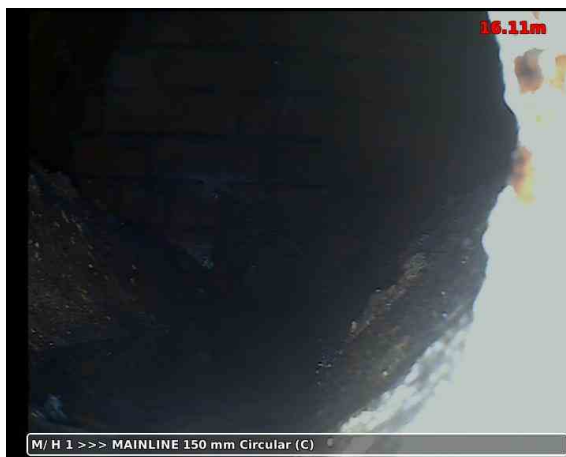
20220217-111814-snap0002.jpg, 00:03:25, 16.11 m
Finish node, manhole, reference: 2

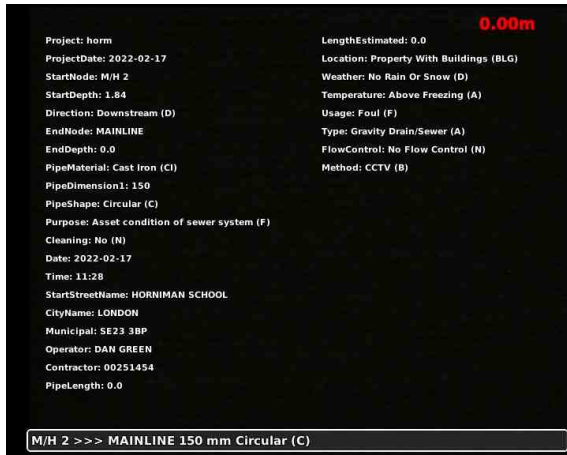
20220217-113011-snap0000.jpg, 00:00:02, 0.00 m
Start node, manhole, reference: 2

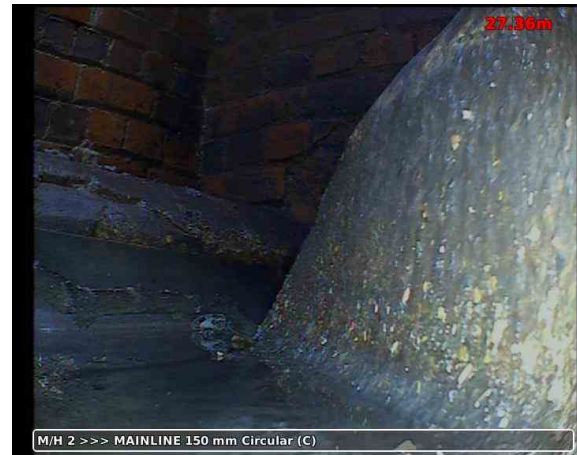
20220217-113011-snap0001.jpg, 00:07:30, 27.36 m
Finish node, manhole, reference: 3

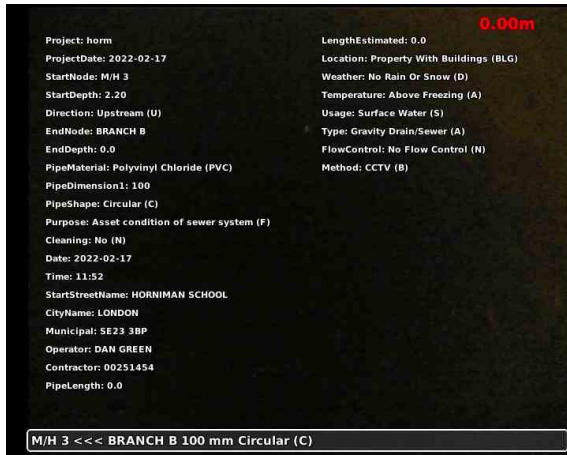
20220217-115213-snap0000.jpg, 00:00:02, 0.00 m
Start node, manhole, reference: 3

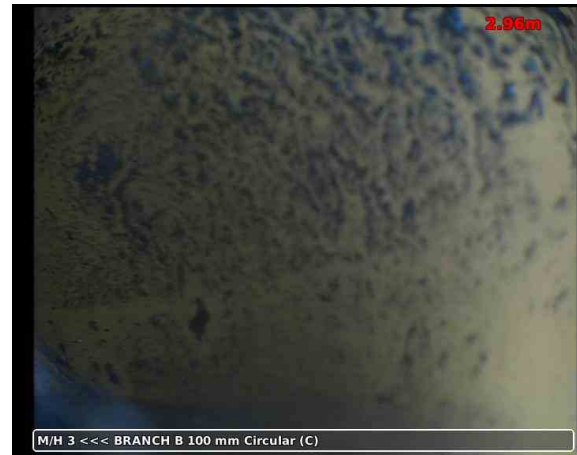
20220217-115213-snap0001.jpg, 00:00:26, 2.96 m
Line deviates left

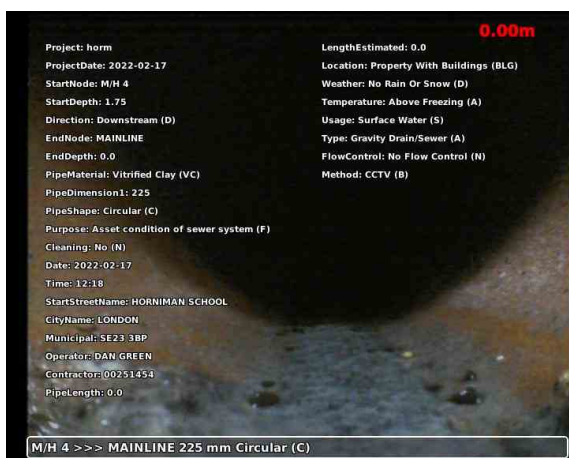
20220217-121917-snap0000.jpg, 00:00:02, 0.00 m
Start node, manhole, reference: 4

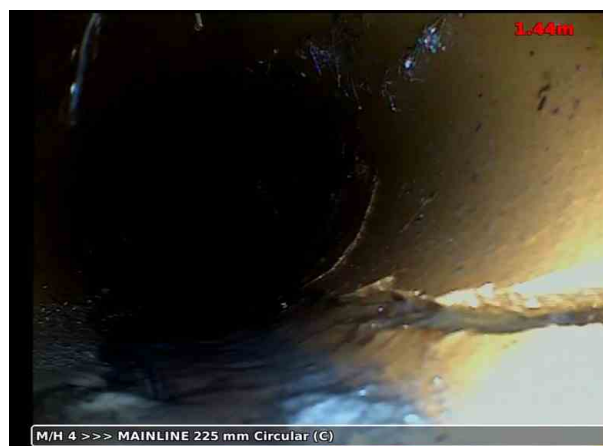
Once on site we lifted all chamber surrounding the pen area, we then surveyed the lines. They all go to manhole 3 and I believe this line to belong to the water board as it seems to take water from the houses behind the school. There also seems to be damage to the 225mm line so I would advise this line is cleaned and surveyed using a crawler camera to be able to fully check the condition of the line. I did also see a connection that possible could serve a drain under the floor inside the pen.

M_H
4X_4108fbbc-3dd6-4015-a3fe-9597ee2b423d_20220217_142
950_455.jpg, 00:00:34, 1.44 m
Broken pipe at 5 o'clock

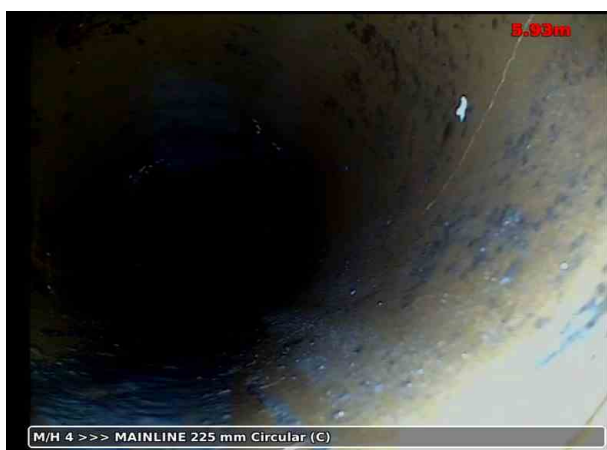
M_H
4X_aba8605c-8b30-415c-8ca0-3a3fb9aebfbf_20220217_1430
55_938.jpg, 00:01:21, 5.93 m
Crack, circumferential from 2 o'clock to 5 o'clock

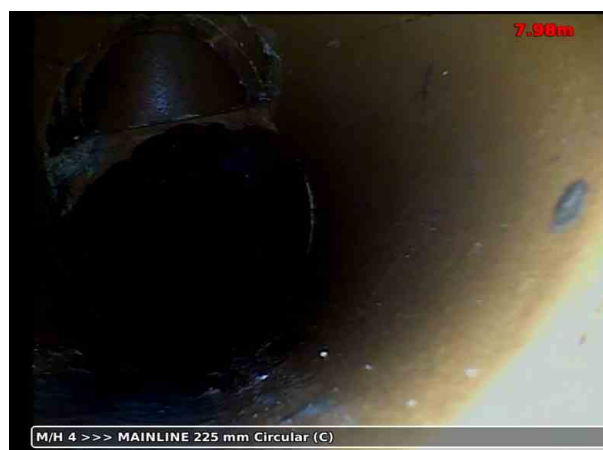
M_H
4X_ec433afb-104d-4d6d-b529-84c26a72ca62_20220217_143
155_326.jpg, 00:01:42, 7.98 m
Connection other than junction at 12 o'clock, 150mm dia

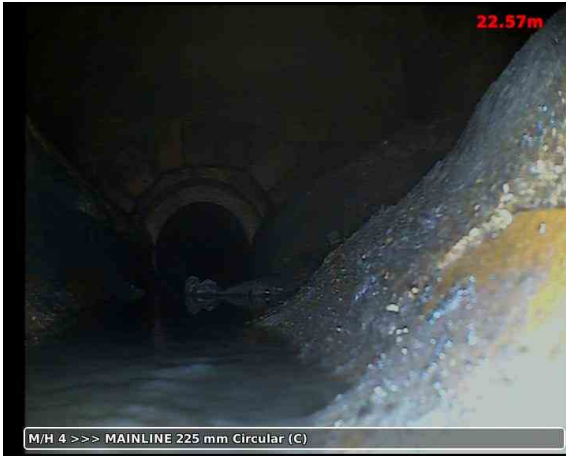
20220217-121917-snap0001.jpg, 00:04:23, 22.57 m
 Finish node, manhole, reference: 3
