ASBESTOS REFURBISHMENT SURVEY
TO 2NO. WINDOWS OF
BRINDISHE LEE PRIMARY SCHOOL, WANTAGE ROAD, LONDON, SE12 8NA

CLIENT: MCBAINS
26 FINSBURY SQUARE, LONDON, EC2A 1DS

UPRN NO: N/A
PROJECT NO: J779198
DATE: April 2022

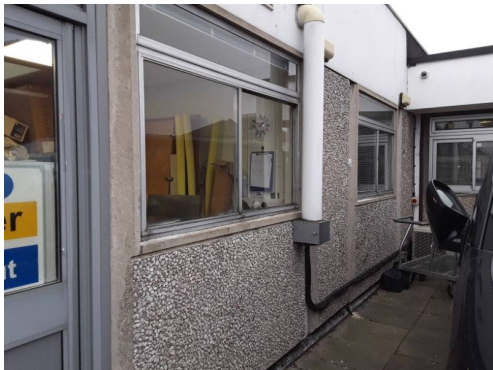
FLOOR/LOCATION:	External	
DESCRIPTION:	Presumed asbestos containing materials within window packers/fixings throughout- unable to inspect without removing the entire windows. (Building is a CLASP construction which has historically been known to containing asbestos containing packers.)	
RECOMMENDATIONS:	Conduct further investigation prior to relevant maintenance / refurbishment / demolition work	
EXTENT:	>50m² or >50m pipe run	
SAMPLE REF:	Presumed	
RESULT:	Presumed Crocidolite (or unknown)

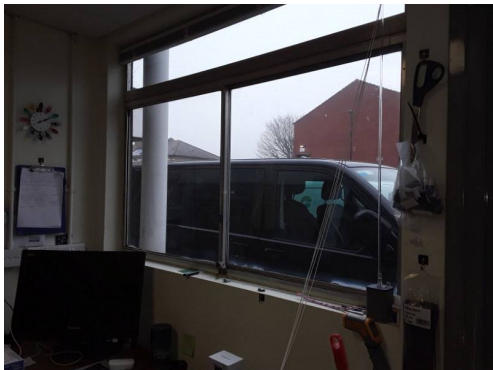
FLOOR/LOCATION:	Ground Floor PO Office (Room 2)	
DESCRIPTION:	Presumed asbestos containing materials within window packers/fixings throughout- unable to inspect without removing the entire windows. (Building is a CLASP construction which has historically been known to containing asbestos containing packers.)	
RECOMMENDATIONS:	Conduct further investigation prior to relevant maintenance / refurbishment / demolition work	
EXTENT:	<10m² or <10m pipe run	
SAMPLE REF:	Presumed	
RESULT:	Presumed Crocidolite (or unknown)

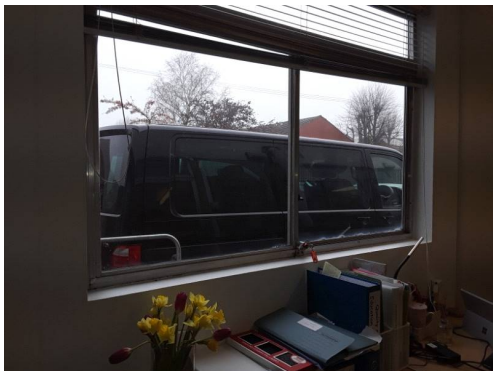
FLOOR/LOCATION:	Ground Floor Executive Headteachers Office (Room 57)	
DESCRIPTION:	Presumed asbestos containing materials within window packers/fixings throughout- unable to inspect without removing the entire windows. (Building is a CLASP construction which has historically been known to containing asbestos containing packers.)	
RECOMMENDATIONS:	Conduct further investigation prior to relevant maintenance / refurbishment / demolition work	
EXTENT:	<10m² or <10m pipe run	
SAMPLE REF:	Presumed

RESULT:	Presumed Crocidolite (or unknown)	
----------------	--------------------------------------	--
