**ASBESTOS REINSPECTION SURVEY
OF
BRINDISHE LEE PRIMARY SCHOOL, WANTAGE ROAD, LONDON, SE12 8NA**

**CLIENT: BRINDISHE LEE PRIMARY SCHOOL
WANTAGE ROAD, LONDON, SE12 8NA**

**UPRN NO: N/A
PROJECT NO: J713550
DATE: August 2021**

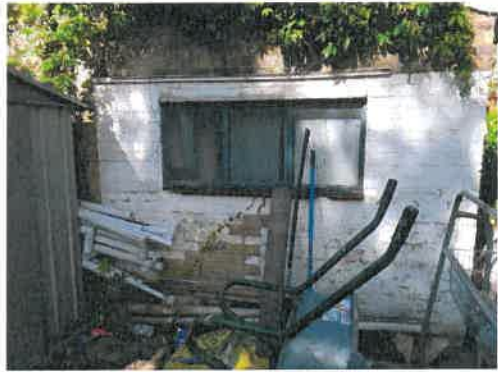
BUILDING NAME:	Main
FLOOR/LOCATION:	External Externals
DESCRIPTION:	Putty seals to windows of garage
RECOMMENDATIONS:	Manage, monitor and inform maintenance personnel prior to relevant works
EXTENT:	<10m ² or <10m pipe run
SAMPLE REF:	SP21 {IB008784}*
RESULT:	Chrysotile

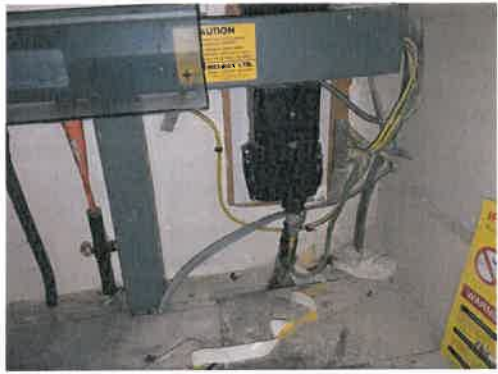
BUILDING NAME:	Main
FLOOR/LOCATION:	Ground Floor Understairs Cupboard (021)
DESCRIPTION:	Insulating board backing panel to fuse box
RECOMMENDATIONS:	Encapsulate
EXTENT:	<10m ² or <10m pipe run
SAMPLE REF:	SP20 {IB008755}*
RESULT:	Chrysotile

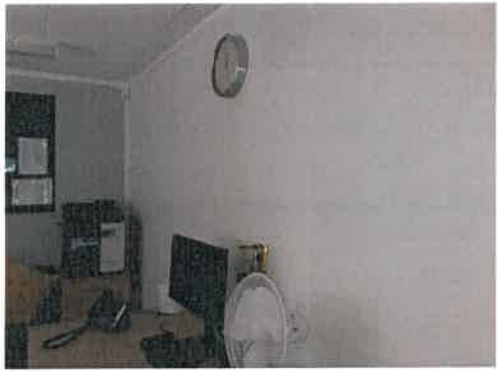
BUILDING NAME:	Main
FLOOR/LOCATION:	Ground Floor A002 Executive Heads Office (001)
DESCRIPTION:	Insulating board wall panels
RECOMMENDATIONS:	Manage, monitor and inform maintenance personnel prior to relevant works
EXTENT:	10 - 50 m ² or 10 - 50m pipe run
SAMPLE REF:	SP1 {IB008756}*
RESULT:	Chrysotile

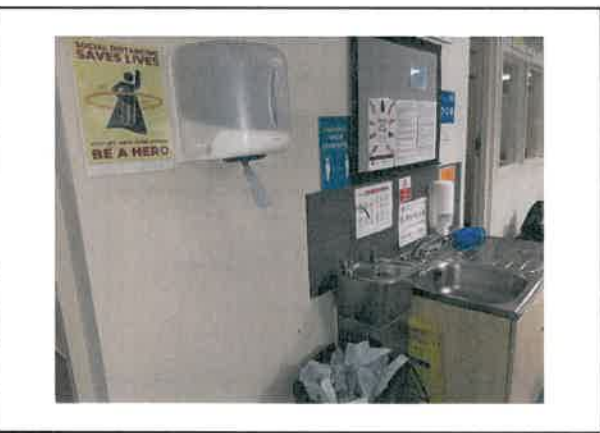
BUILDING NAME:	Main
FLOOR/LOCATION:	Ground Floor A001 Shared Work Area (002)
DESCRIPTION:	Insulating board wall panels
RECOMMENDATIONS:	Manage, monitor and inform maintenance personnel prior to relevant works
EXTENT:	10 - 50 m ² or 10 - 50m pipe run
SAMPLE REF:	SP1 {IB008757}*
RESULT:	Chrysotile

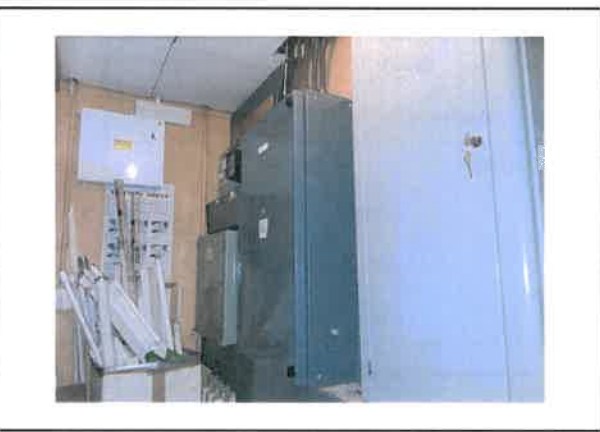
BUILDING NAME:	Main
FLOOR/LOCATION:	Ground Floor A003 Electrical Cupboard (003)
DESCRIPTION:	Insulating board wall panels throughout
RECOMMENDATIONS:	Manage, monitor and inform maintenance personnel prior to relevant works
EXTENT:	10 - 50 m ² or 10 - 50m pipe run
SAMPLE REF:	SP3 {IB008758}*
RESULT:	Chrysotile

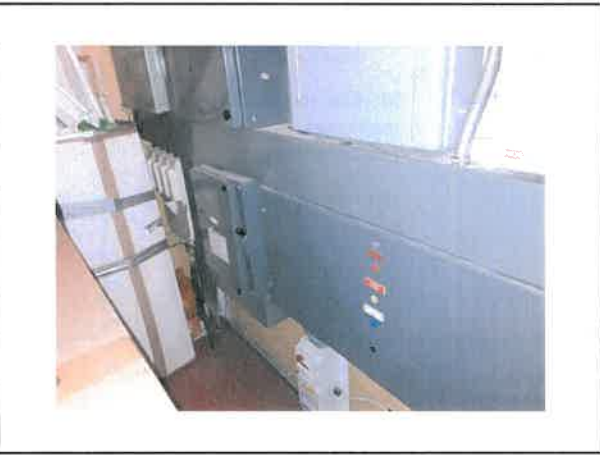
BUILDING NAME:	Main
FLOOR/LOCATION:	Ground Floor A003 Electrical Cupboard (003)
DESCRIPTION:	Presumed asbestos containing materials within live electrics
RECOMMENDATIONS:	Conduct further investigation prior to relevant maintenance / refurbishment / demolition work
EXTENT:	<10m ² or <10m pipe run
SAMPLE REF:	Presumed
RESULT:	Presumed Crocidolite (or unknown)

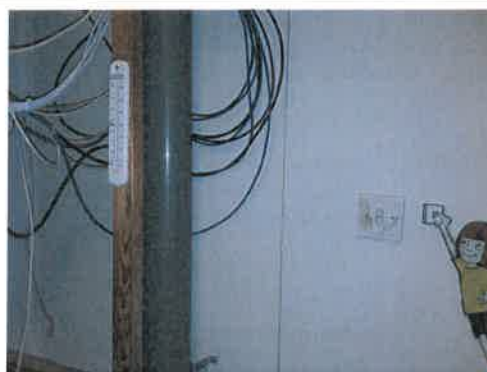
BUILDING NAME:	Main
FLOOR/LOCATION:	Ground Floor A004 Stock Room (004)
DESCRIPTION:	Insulating board wall panels throughout
RECOMMENDATIONS:	Manage, monitor and inform maintenance personnel prior to relevant works
EXTENT:	10 - 50 m ² or 10 - 50m pipe run
SAMPLE REF:	SP5 {IB008759}*
RESULT:	Chrysotile

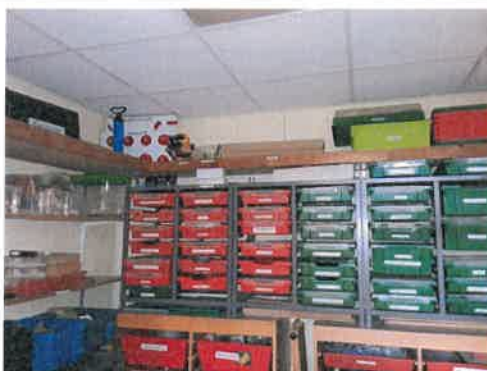
BUILDING NAME:	Main
FLOOR/LOCATION:	Ground Floor A006 Store (005)
DESCRIPTION:	Insulating board wall panels throughout
RECOMMENDATIONS:	Manage, monitor and inform maintenance personnel prior to relevant works
EXTENT:	10 - 50 m ² or 10 - 50m pipe run
SAMPLE REF:	SP6 {IB008760}*
RESULT:	Chrysotile

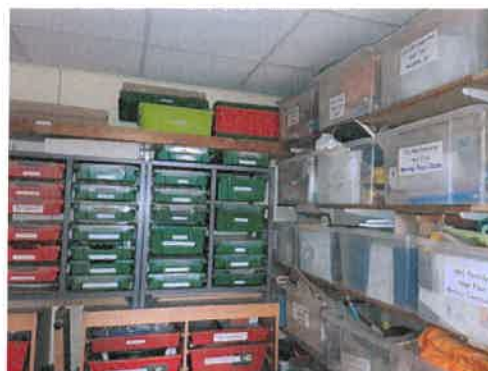
BUILDING NAME:	Main
FLOOR/LOCATION:	Ground Floor A008 Resource Store (006)
DESCRIPTION:	Insulating board wall panels throughout
RECOMMENDATIONS:	Manage, monitor and inform maintenance personnel prior to relevant works
EXTENT:	10 - 50 m ² or 10 - 50m pipe run
SAMPLE REF:	SP7 {IB008761}*
RESULT:	Chrysotile

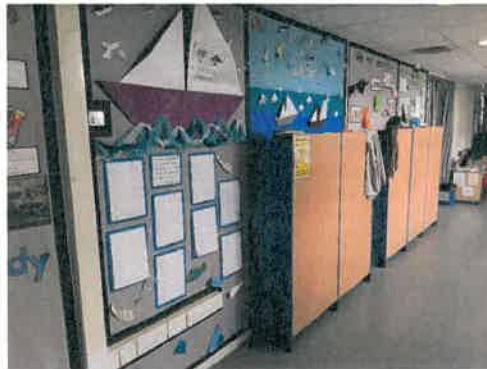
BUILDING NAME:	Main
FLOOR/LOCATION:	Ground Floor A021 Shared Work Area
DESCRIPTION:	Insulating board wall panels throughout
RECOMMENDATIONS:	Manage, monitor and inform maintenance personnel prior to relevant works
EXTENT:	10 - 50 m ² or 10 - 50m pipe run
SAMPLE REF:	SP8 {IB008762}*
RESULT:	Chrysotile

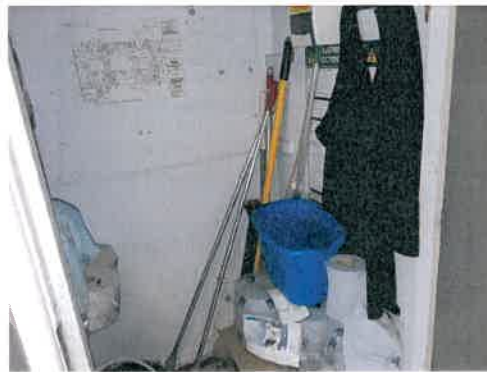
BUILDING NAME:	Main
FLOOR/LOCATION:	Ground Floor A017 Cleaners Cupboard
DESCRIPTION:	Insulating board wall panels
RECOMMENDATIONS:	Manage, monitor and inform maintenance personnel prior to relevant works
EXTENT:	<10m ² or <10m pipe run
SAMPLE REF:	SP9 {IB008763}*
RESULT:	Chrysotile

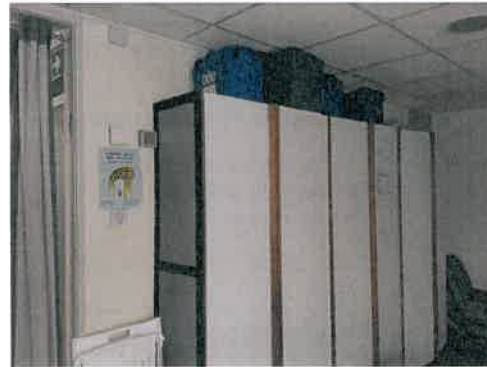
BUILDING NAME:	Main
FLOOR/LOCATION:	Ground Floor A018 Classroom Year 2 (010)
DESCRIPTION:	Insulating board wall panels
RECOMMENDATIONS:	Manage, monitor and inform maintenance personnel prior to relevant works
EXTENT:	10 - 50 m ² or 10 - 50m pipe run
SAMPLE REF:	SP10 {IB008764}*
RESULT:	Chrysotile

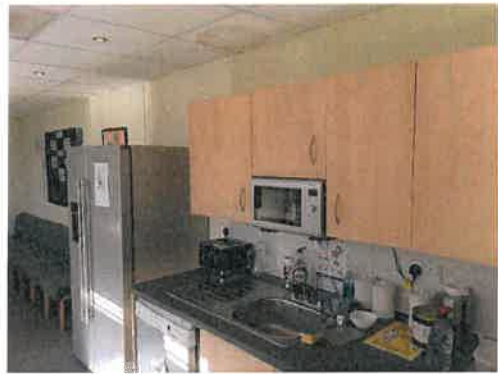
BUILDING NAME:	Main
FLOOR/LOCATION:	Ground Floor A032 Staff Room (011)
DESCRIPTION:	Insulating board wall panels
RECOMMENDATIONS:	Manage, monitor and inform maintenance personnel prior to relevant works
EXTENT:	10 - 50 m ² or 10 - 50m pipe run
SAMPLE REF:	SP11 {IB008765}*
RESULT:	Chrysotile

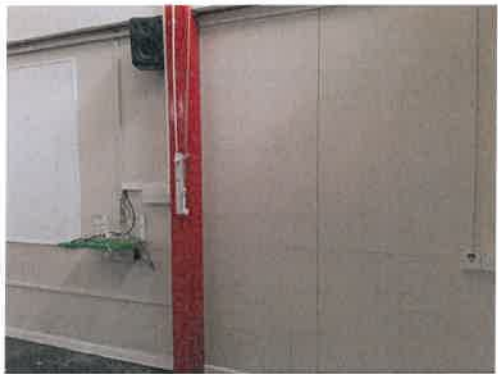
BUILDING NAME:	Main
FLOOR/LOCATION:	Ground Floor A041 Hall (012)
DESCRIPTION:	Insulating board wall panels
RECOMMENDATIONS:	Manage, monitor and inform maintenance personnel prior to relevant works
EXTENT:	>50m ² or >50m pipe run
SAMPLE REF:	SP12 {IB008766}*
RESULT:	Chrysotile

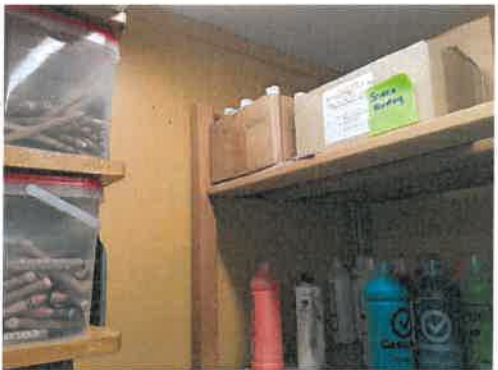
BUILDING NAME:	Main
FLOOR/LOCATION:	Ground Floor A034 Nursery Store (013)
DESCRIPTION:	Insulating board wall panels
RECOMMENDATIONS:	Manage, monitor and inform maintenance personnel prior to relevant works
EXTENT:	10 - 50 m ² or 10 - 50m pipe run
SAMPLE REF:	SP13 {IB008767}*
RESULT:	Chrysotile

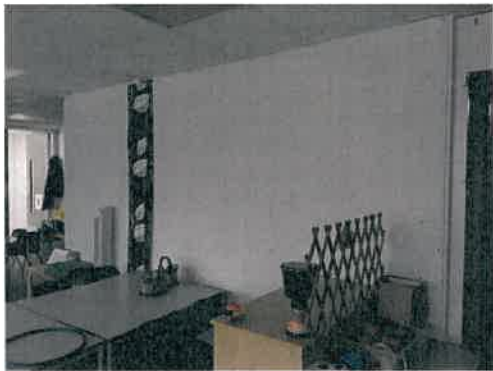
BUILDING NAME:	Main
FLOOR/LOCATION:	Ground Floor A033 Nursery Classroom (014)
DESCRIPTION:	Insulating board wall panels
RECOMMENDATIONS:	Manage, monitor and inform maintenance personnel prior to relevant works
EXTENT:	<10m ² or <10m pipe run
SAMPLE REF:	SP14 {IB008768}*
RESULT:	Chrysotile

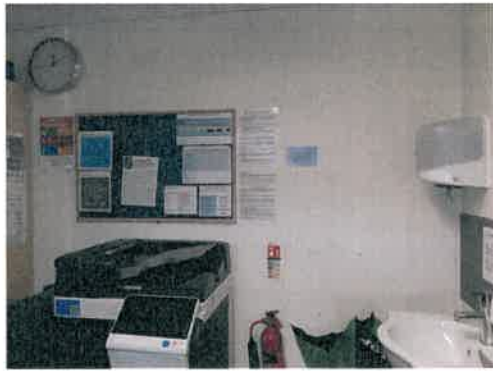
BUILDING NAME:	Main
FLOOR/LOCATION:	Ground Floor A040 Medical Room (015)
DESCRIPTION:	Insulating board wall panels
RECOMMENDATIONS:	Manage, monitor and inform maintenance personnel prior to relevant works
EXTENT:	<10m ² or <10m pipe run
SAMPLE REF:	SP15 {IB008769}*
RESULT:	Chrysotile

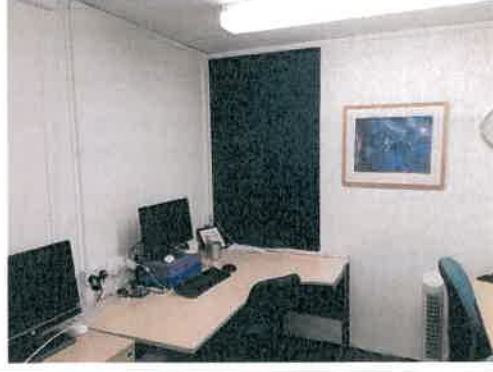
BUILDING NAME:	Main
FLOOR/LOCATION:	Ground Floor A042 Staff Work Area
DESCRIPTION:	Insulating board wall panels
RECOMMENDATIONS:	Manage, monitor and inform maintenance personnel prior to relevant works
EXTENT:	10 - 50 m ² or 10 - 50m pipe run
SAMPLE REF:	SP16 {IB008770}*
RESULT:	Chrysotile

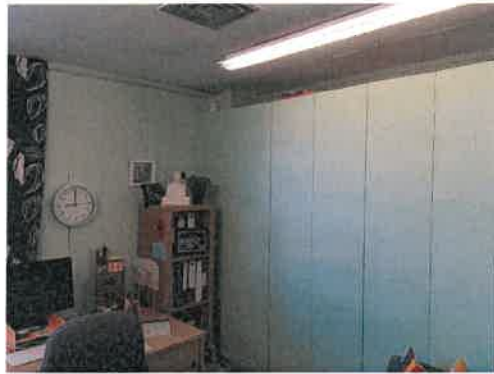
BUILDING NAME:	Main
FLOOR/LOCATION:	Ground Floor A051 A&H Resources (017)
DESCRIPTION:	Insulating board wall panels
RECOMMENDATIONS:	Manage, monitor and inform maintenance personnel prior to relevant works
EXTENT:	10 - 50 m ² or 10 - 50m pipe run
SAMPLE REF:	SP17 {IB008771}*
RESULT:	Chrysotile

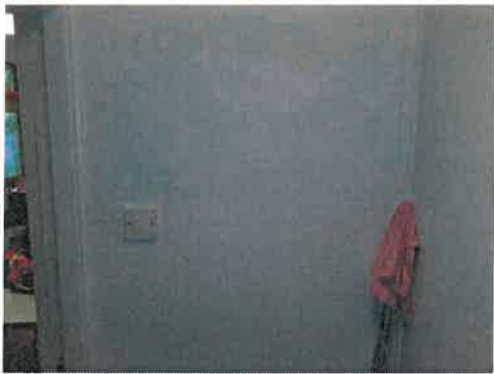
BUILDING NAME:	Main
FLOOR/LOCATION:	Ground Floor A025 Cleaners (018)
DESCRIPTION:	Insulating board wall panels
RECOMMENDATIONS:	Manage, monitor and inform maintenance personnel prior to relevant works
EXTENT:	<10m ² or <10m pipe run
SAMPLE REF:	SP18 {IB008772}*
RESULT:	Chrysotile

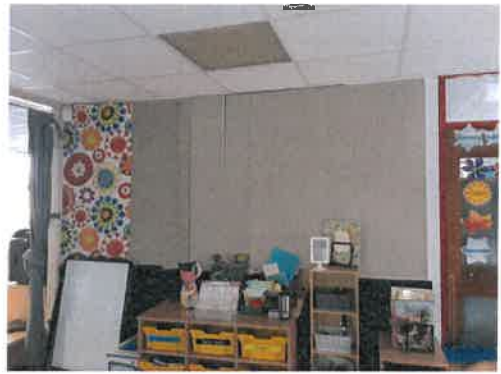
BUILDING NAME:	Main
FLOOR/LOCATION:	Ground Floor A023 Reception Class (019)
DESCRIPTION:	Insulating board wall panels
RECOMMENDATIONS:	Manage, monitor and inform maintenance personnel prior to relevant works
EXTENT:	10 - 50 m ² or 10 - 50m pipe run
SAMPLE REF:	SP19 {IB008773}*
RESULT:	Chrysotile

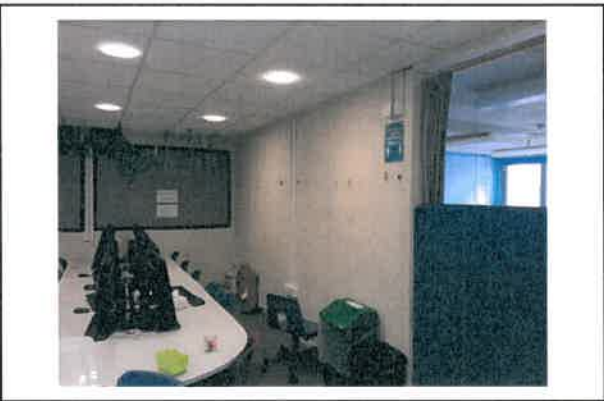
BUILDING NAME:	Main
FLOOR/LOCATION:	Ground Floor A044 SENCO (020)
DESCRIPTION:	Insulating board wall panels
RECOMMENDATIONS:	Manage, monitor and inform maintenance personnel prior to relevant works
EXTENT:	10 - 50 m ² or 10 - 50m pipe run
SAMPLE REF:	SP22 {IB008774}*
RESULT:	Chrysotile

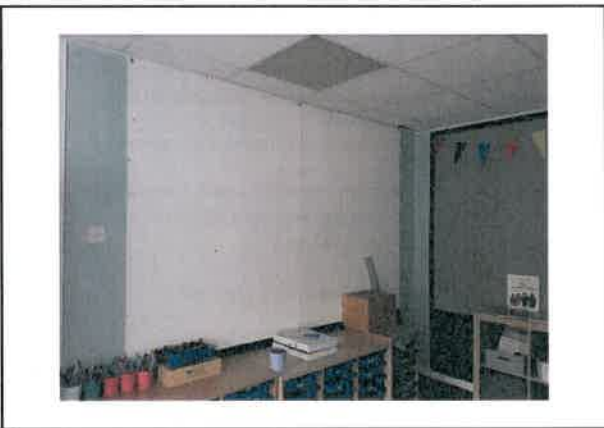
BUILDING NAME:	Main
FLOOR/LOCATION:	Ground Floor A022 LSGP Group Room (024)
DESCRIPTION:	Insulating board wall panels
RECOMMENDATIONS:	Manage, monitor and inform maintenance personnel prior to relevant works
EXTENT:	10 - 50 m ² or 10 - 50m pipe run
SAMPLE REF:	SP23 {IB008775}*
RESULT:	Chrysotile

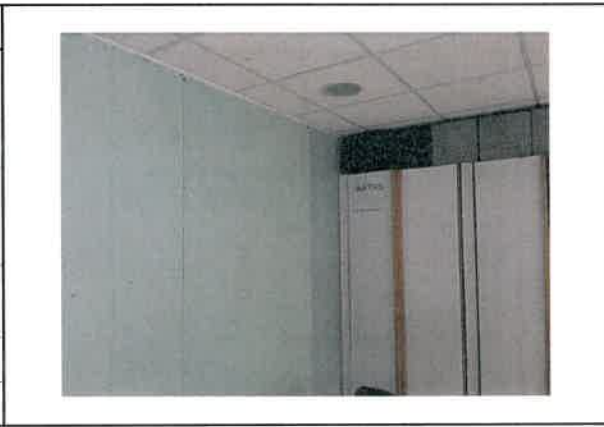
BUILDING NAME:	Main
FLOOR/LOCATION:	Ground Floor A020 Classroom Year 1 (025)
DESCRIPTION:	Insulating board wall panels
RECOMMENDATIONS:	Manage, monitor and inform maintenance personnel prior to relevant works
EXTENT:	10 - 50 m ² or 10 - 50m pipe run
SAMPLE REF:	SP24 {IB008776}*
RESULT:	Chrysotile

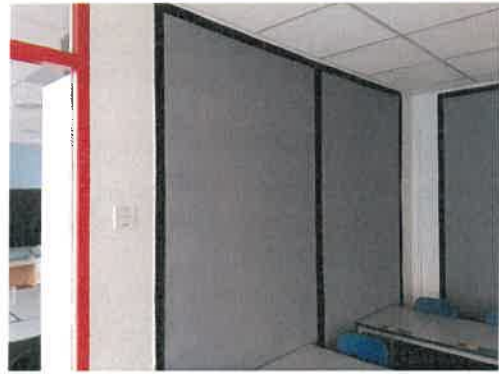
BUILDING NAME:	Main
FLOOR/LOCATION:	Ground Floor AO19 Group Room (023)
DESCRIPTION:	Insulating board wall panels
RECOMMENDATIONS:	Encapsulate
EXTENT:	10 - 50 m ² or 10 - 50m pipe run
SAMPLE REF:	SP25 {IB008777}*
RESULT:	Chrysotile

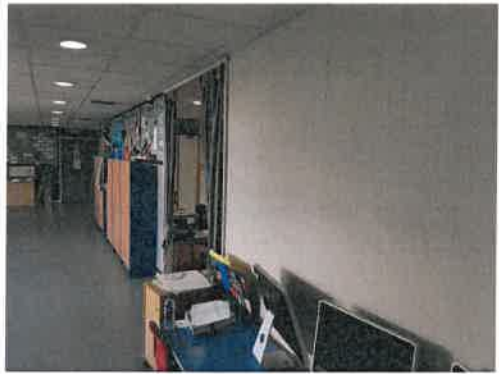
BUILDING NAME:	Main
FLOOR/LOCATION:	Ground Floor AO15 Shared Work Area (026)
DESCRIPTION:	Insulating board wall panels
RECOMMENDATIONS:	Manage, monitor and inform maintenance personnel prior to relevant works
EXTENT:	10 - 50 m ² or 10 - 50m pipe run
SAMPLE REF:	SP26 {IB008778}*
RESULT:	Chrysotile

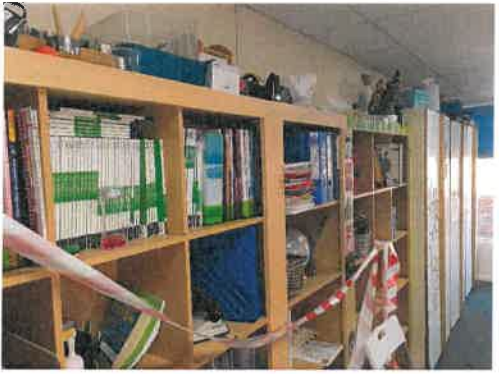
BUILDING NAME:	Main
FLOOR/LOCATION:	Ground Floor AO50 Classroom Year 6 (027)
DESCRIPTION:	Insulating board wall panels
RECOMMENDATIONS:	Manage, monitor and inform maintenance personnel prior to relevant works
EXTENT:	10 - 50 m ² or 10 - 50m pipe run
SAMPLE REF:	SP27 {IB008779}*
RESULT:	Chrysotile

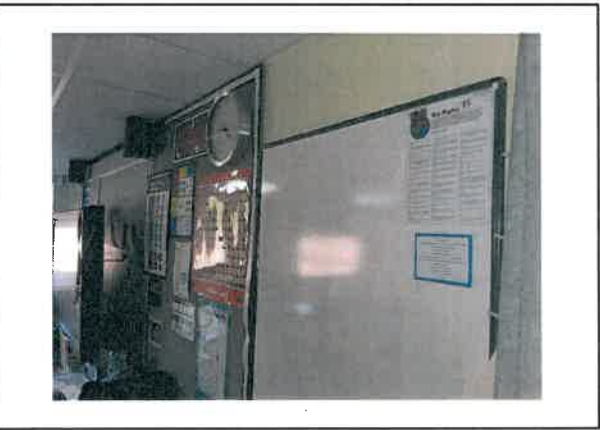
BUILDING NAME:	Main
FLOOR/LOCATION:	Ground Floor AO49 Classroom Year 5 (028)
DESCRIPTION:	Insulating board wall panels
RECOMMENDATIONS:	Manage, monitor and inform maintenance personnel prior to relevant works
EXTENT:	10 - 50 m ² or 10 - 50m pipe run
SAMPLE REF:	SP28 {IB008780}*
RESULT:	Chrysotile

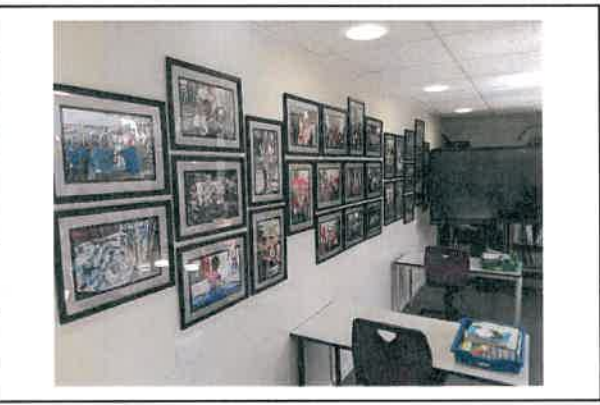
BUILDING NAME:	Main
FLOOR/LOCATION:	Ground Floor AO48 Library (029)
DESCRIPTION:	Insulating board wall panels
RECOMMENDATIONS:	Manage, monitor and inform maintenance personnel prior to relevant works
EXTENT:	10 - 50 m ² or 10 - 50m pipe run
SAMPLE REF:	SP29 {IB008781}*
RESULT:	Chrysotile

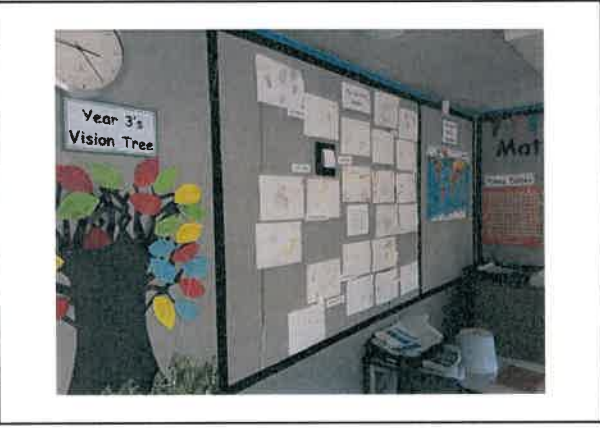
BUILDING NAME:	Main
FLOOR/LOCATION:	Ground Floor AO45 Classroom Year 3 (030)
DESCRIPTION:	Insulating board wall panels
RECOMMENDATIONS:	Manage, monitor and inform maintenance personnel prior to relevant works
EXTENT:	10 - 50 m ² or 10 - 50m pipe run
SAMPLE REF:	SP30 {IB008782}*
RESULT:	Chrysotile

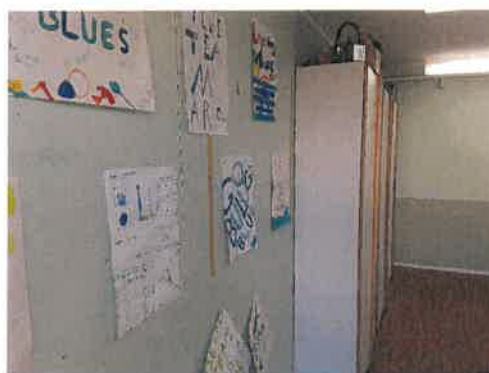
BUILDING NAME:	Main
FLOOR/LOCATION:	Ground Floor AO46 Classroom Year 4 (031)
DESCRIPTION:	Insulating board wall panels
RECOMMENDATIONS:	Manage, monitor and inform maintenance personnel prior to relevant works
EXTENT:	10 - 50 m ² or 10 - 50m pipe run
SAMPLE REF:	SP31 {IB008783}*
RESULT:	Chrysotile
