ASBESTOS SURVEY REPORT

SURVEY TYPE : Refurbishment Survey

SURVEY REPORT NO. : HFS/RS/JD/05885

**ADDRESS : New Watford Station
3 George Street
Watford
Hertfordshire
WD18 0BX**

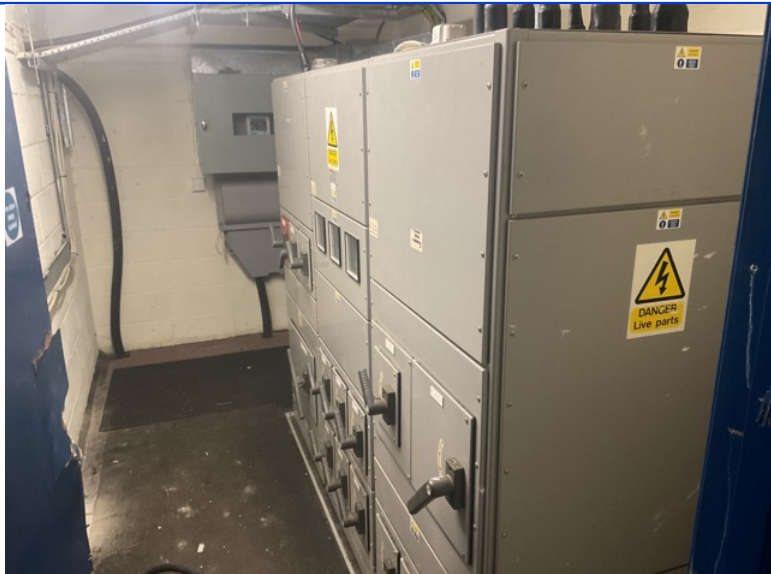
Sample Number	-

Site	New Watford Station, 3 George Street , Watford, Hertfordshire, WD18 0BX		
Building		Floor	B
Location	Main electrical intake room		
Building Component	Electrical Switch Gear		
Material	May Contain Concealed Asbestos		
Area References	0070/05

Analysis Result	Presumed Chrysotile	
Quantity	1 Item

The material is in a good condition and no damage was identified.

Material Assessment Algorithm				Results				
Product Type	Damage	Surface Treatment	Asbestos Type	Material Score	Access	Total	Action Priority	Recommendation
2	0	1	1	4	1	4	Low	Remove
